**WOODBURY COUNTY BOARD OF SUPERVISORS AGENDA ITEM(S) REQUEST FORM****#11c**Date: 8/25/2016Weekly Agenda Date: 8/30/2016**ELECTED OFFICIAL / DEPARTMENT HEAD / CITIZEN:** Kenny Schmitz**WORDING FOR AGENDA ITEM:**

Woodbury County Courthouse Exterior Terra Cotta Report

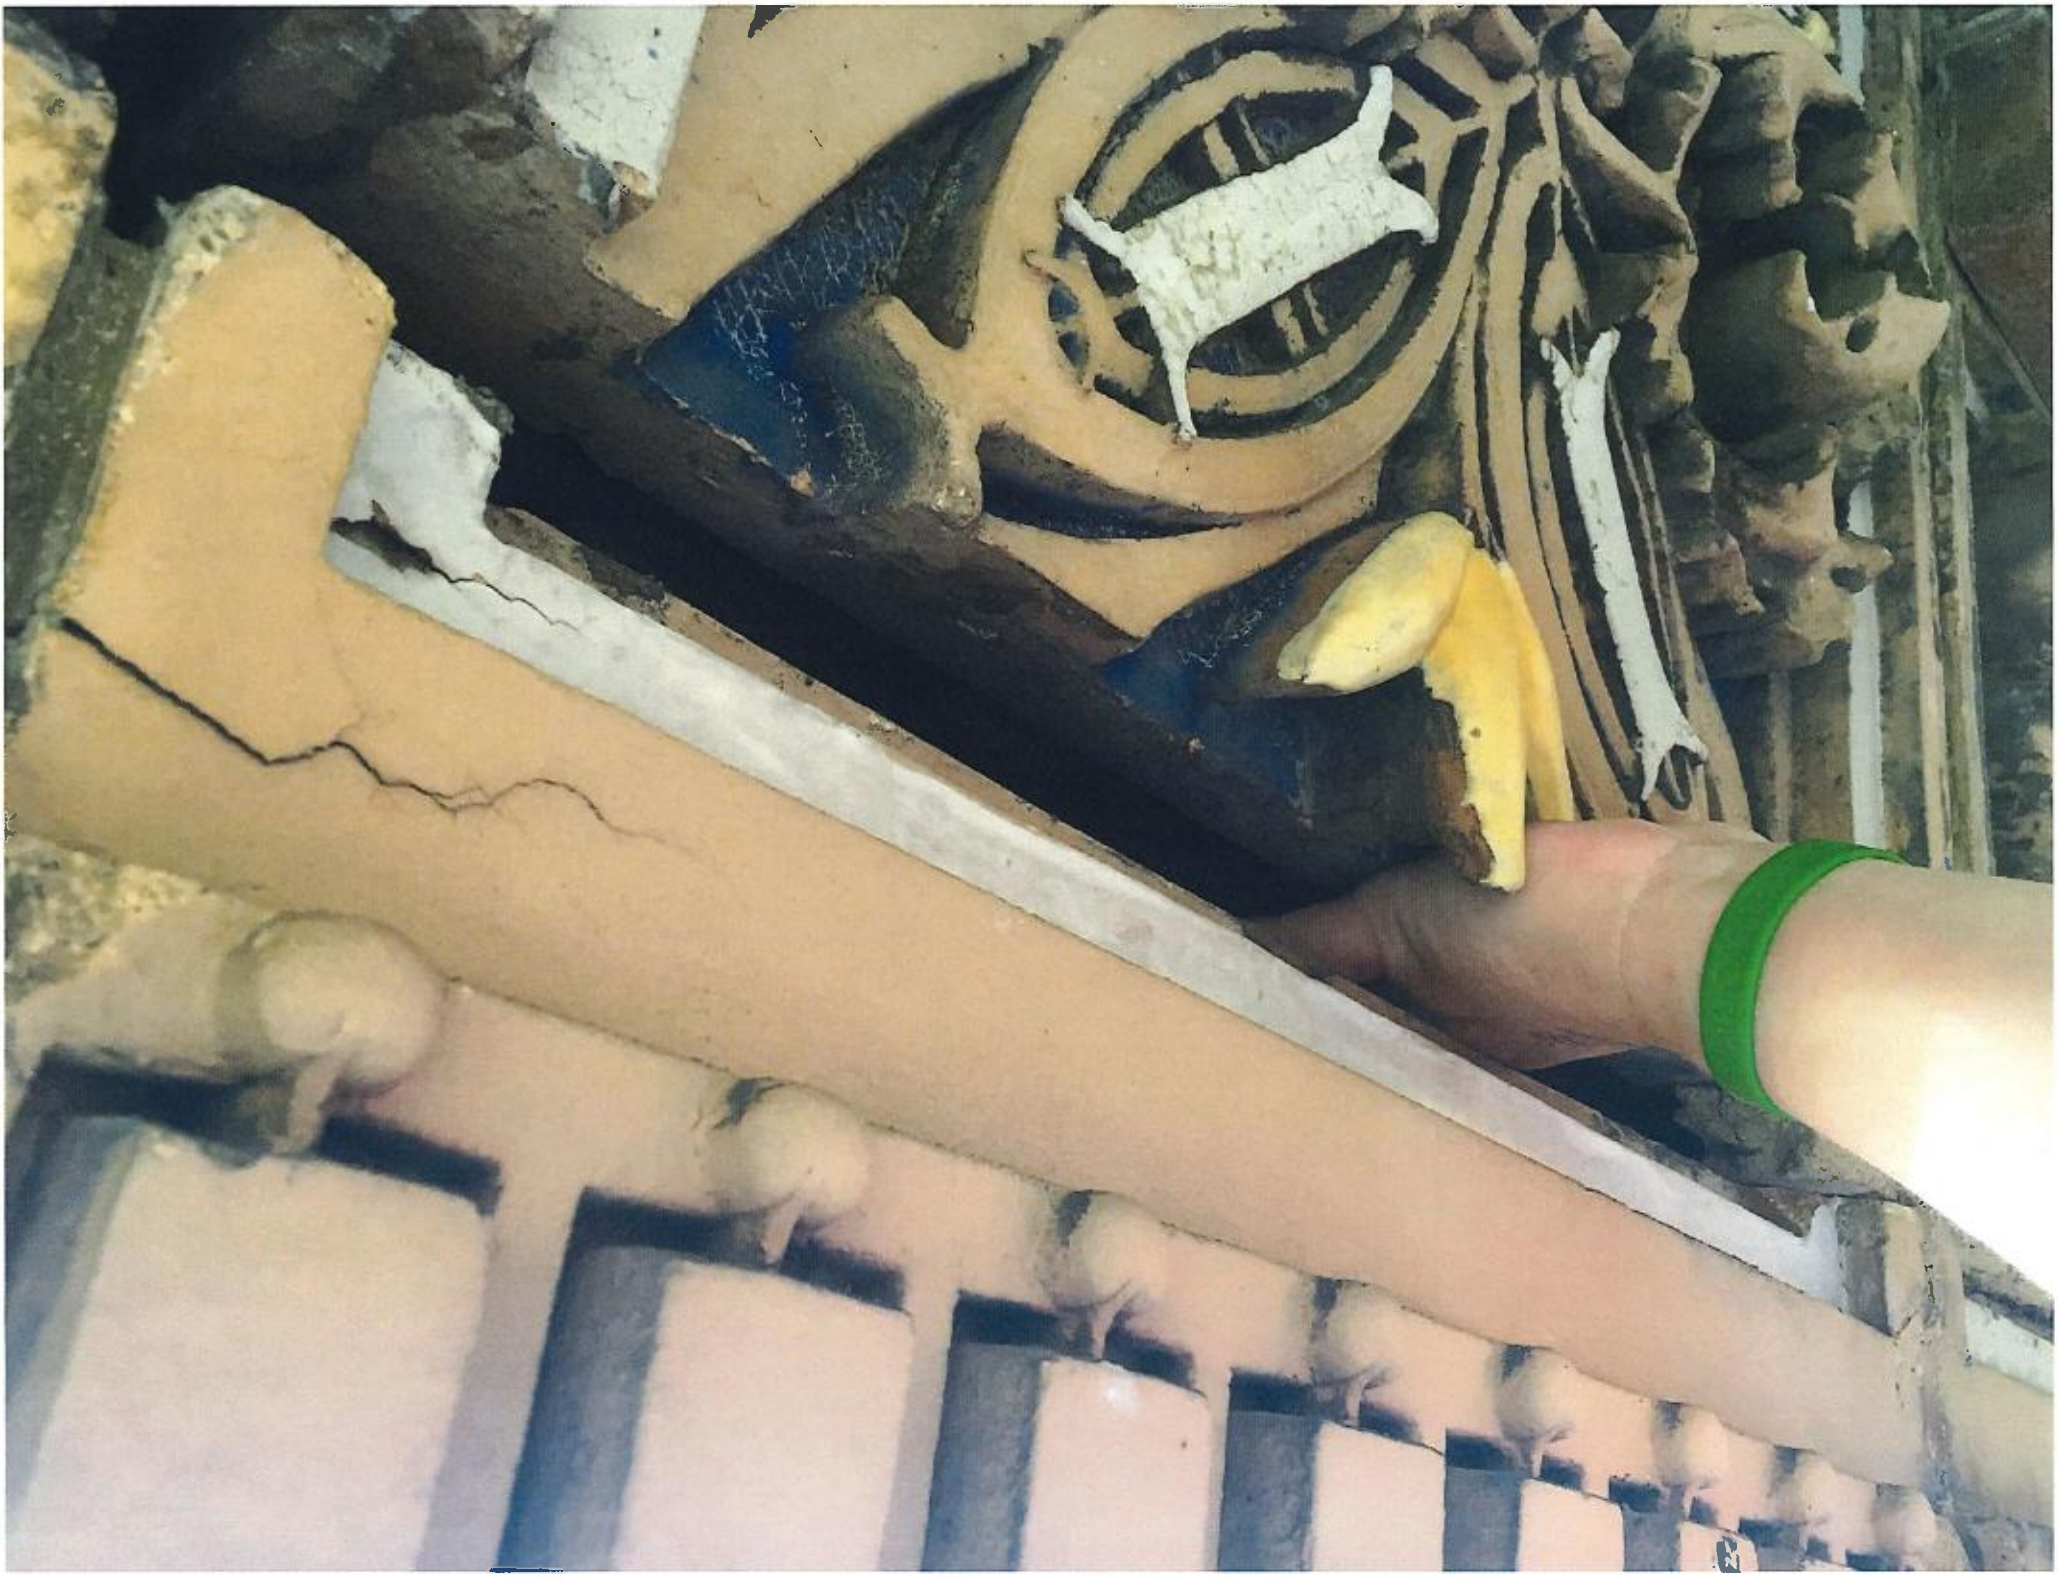
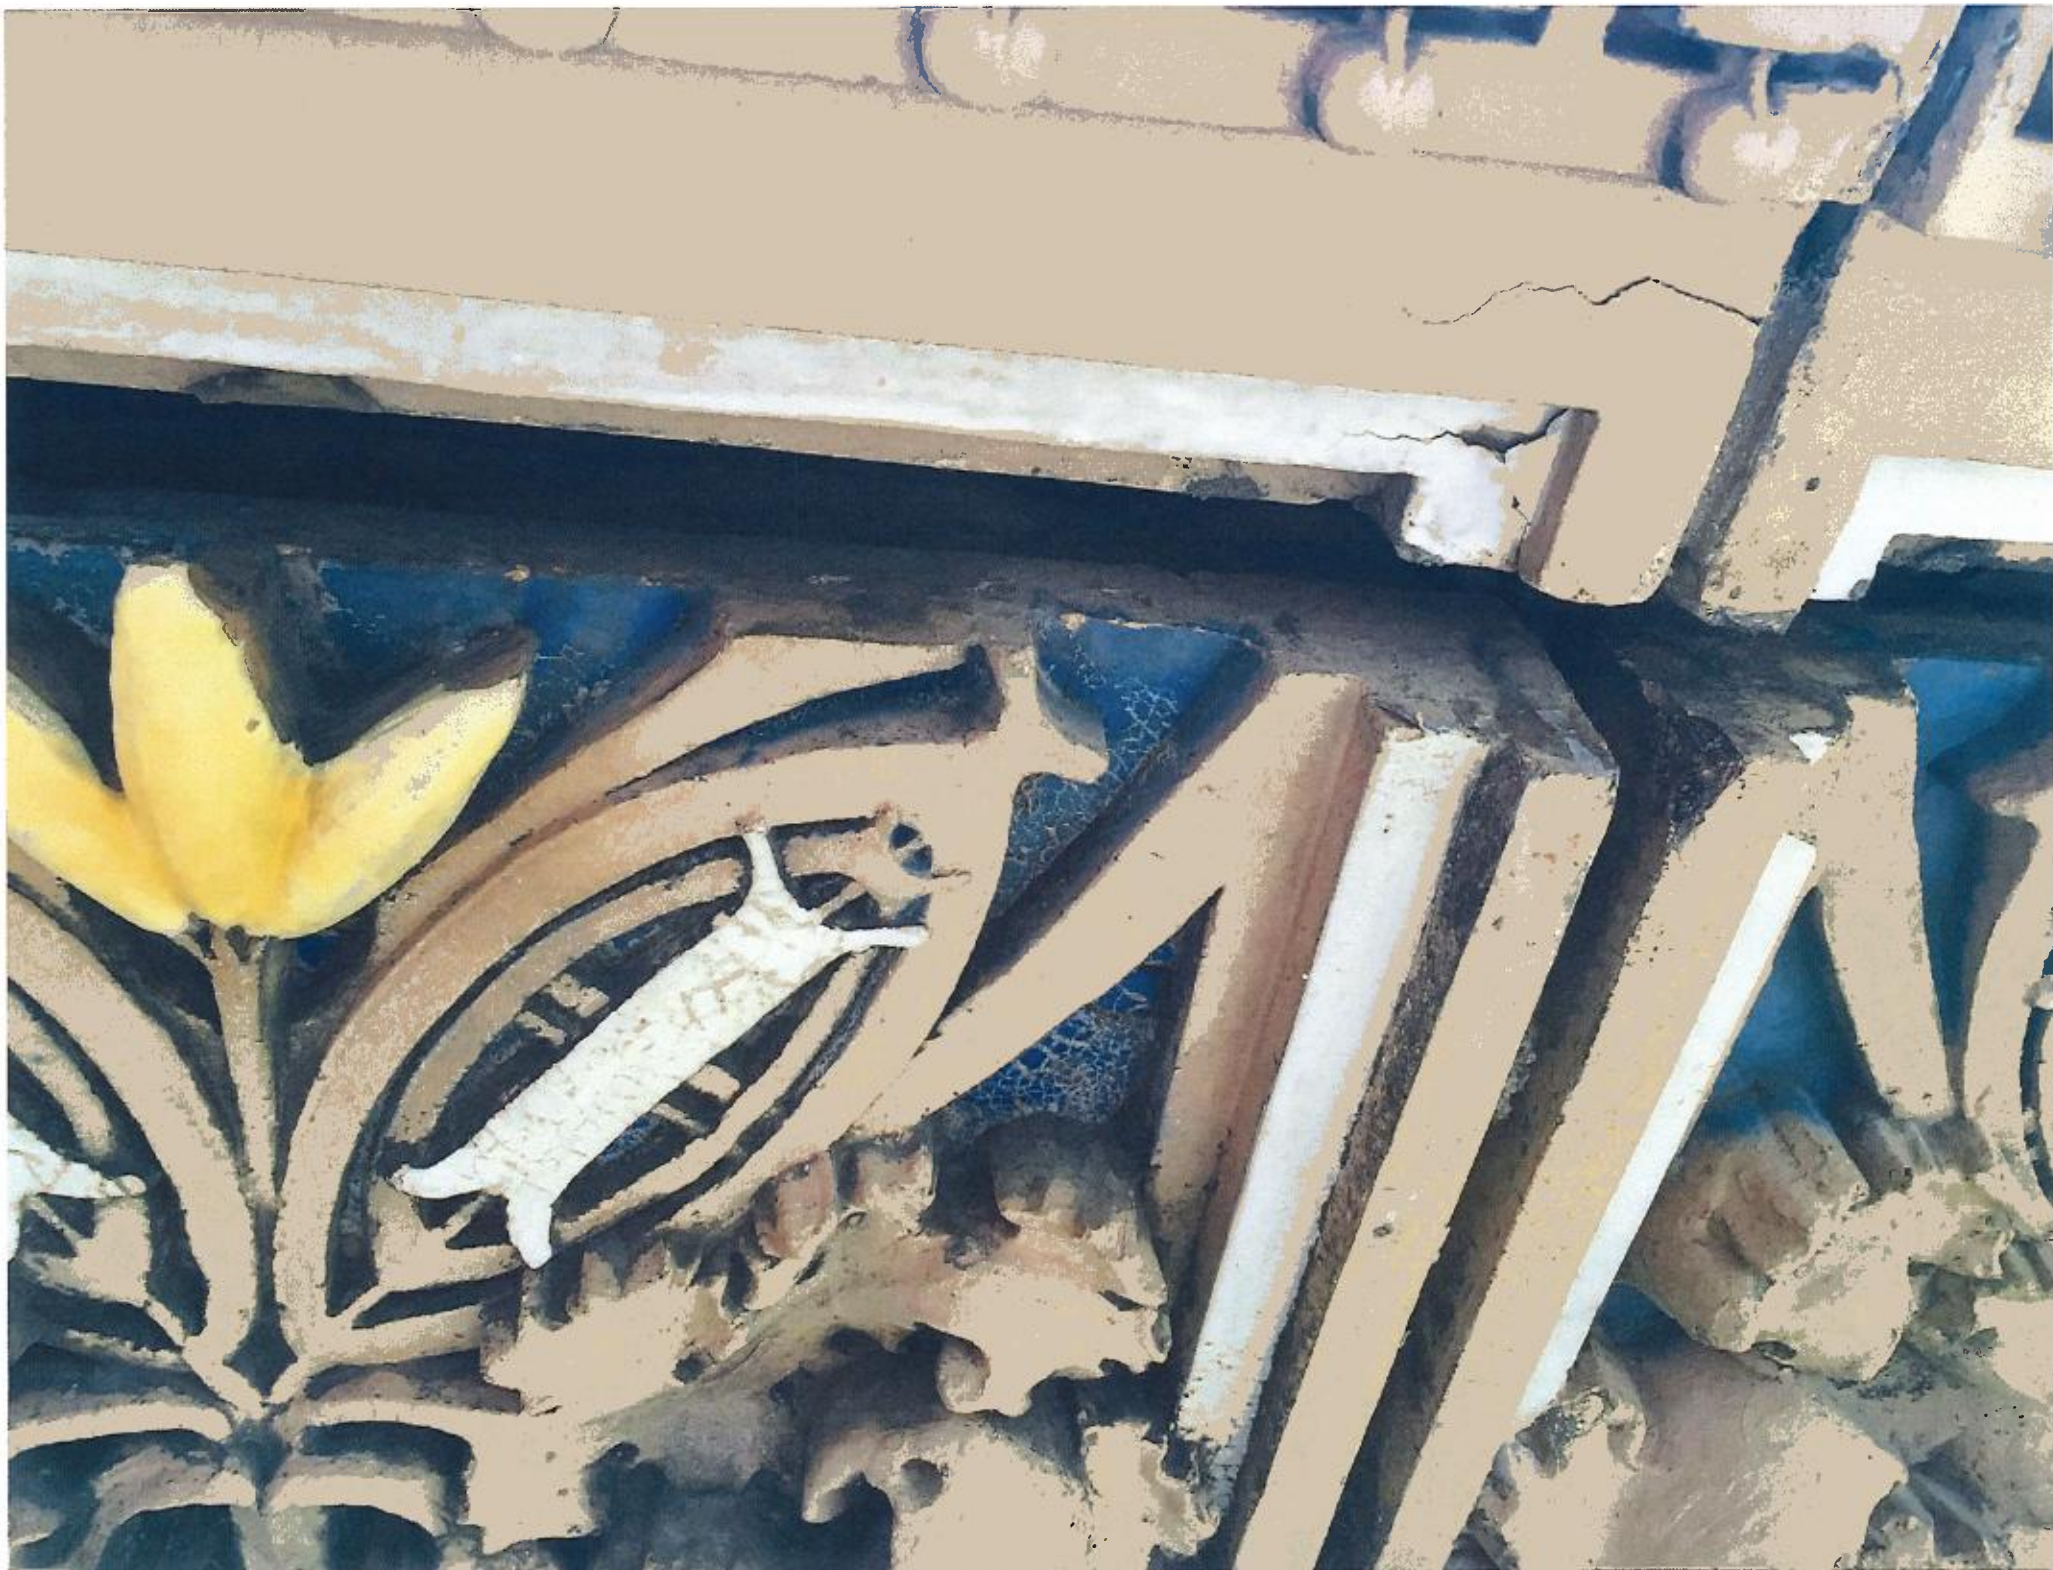
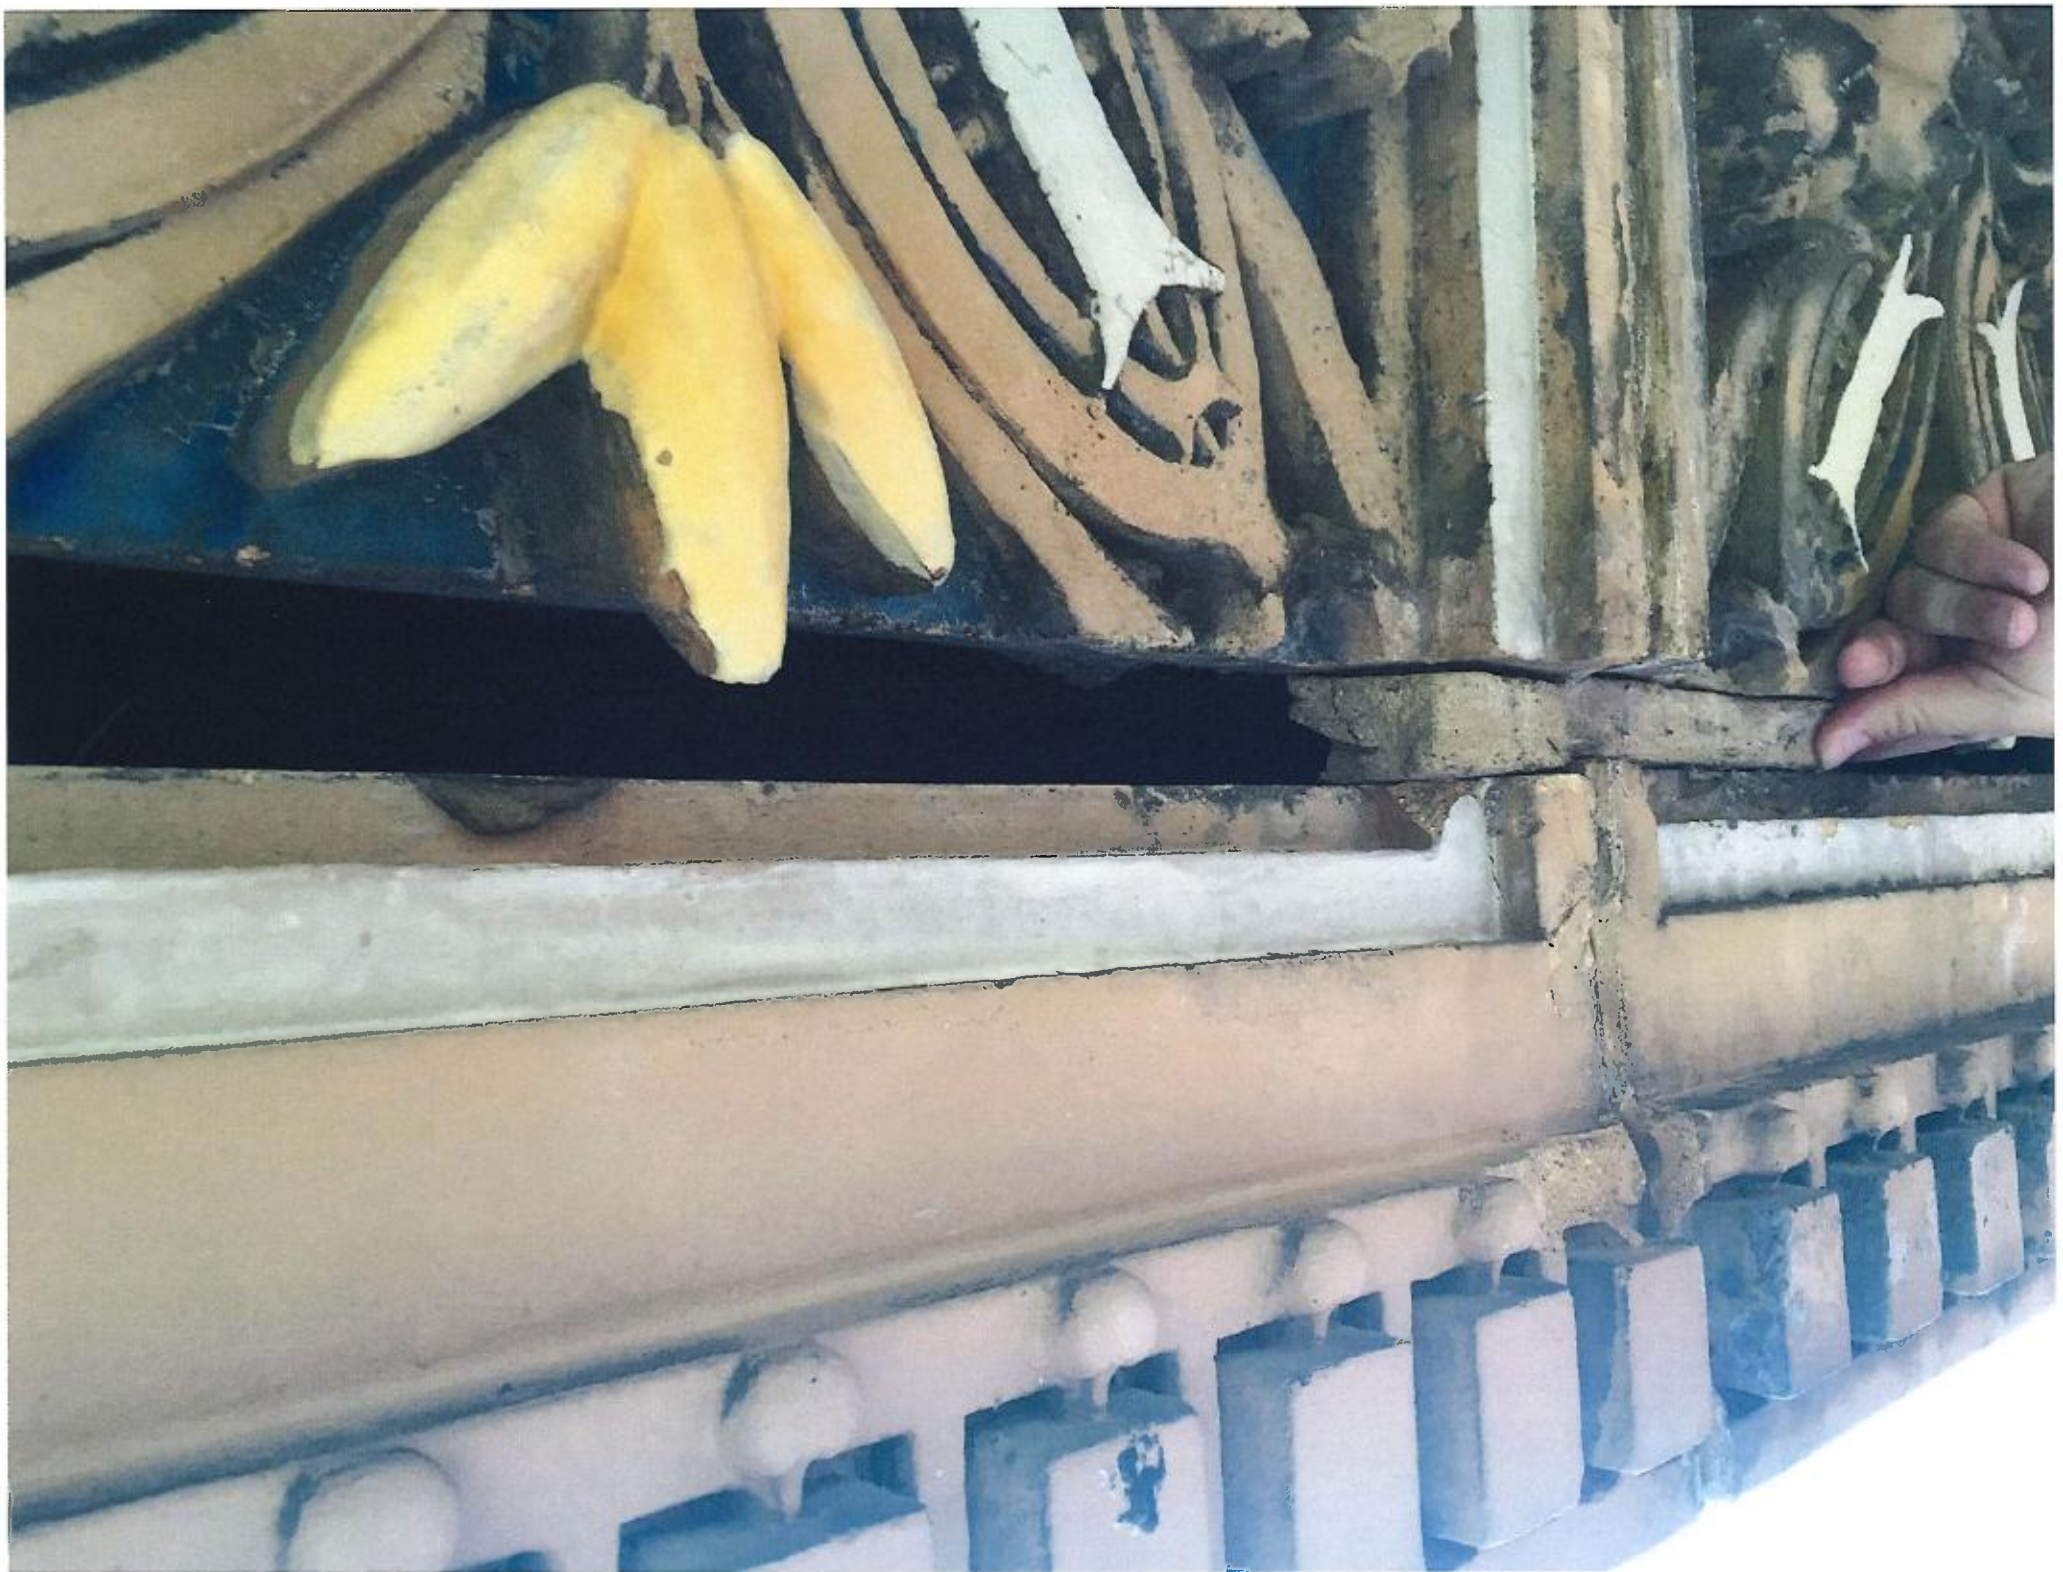
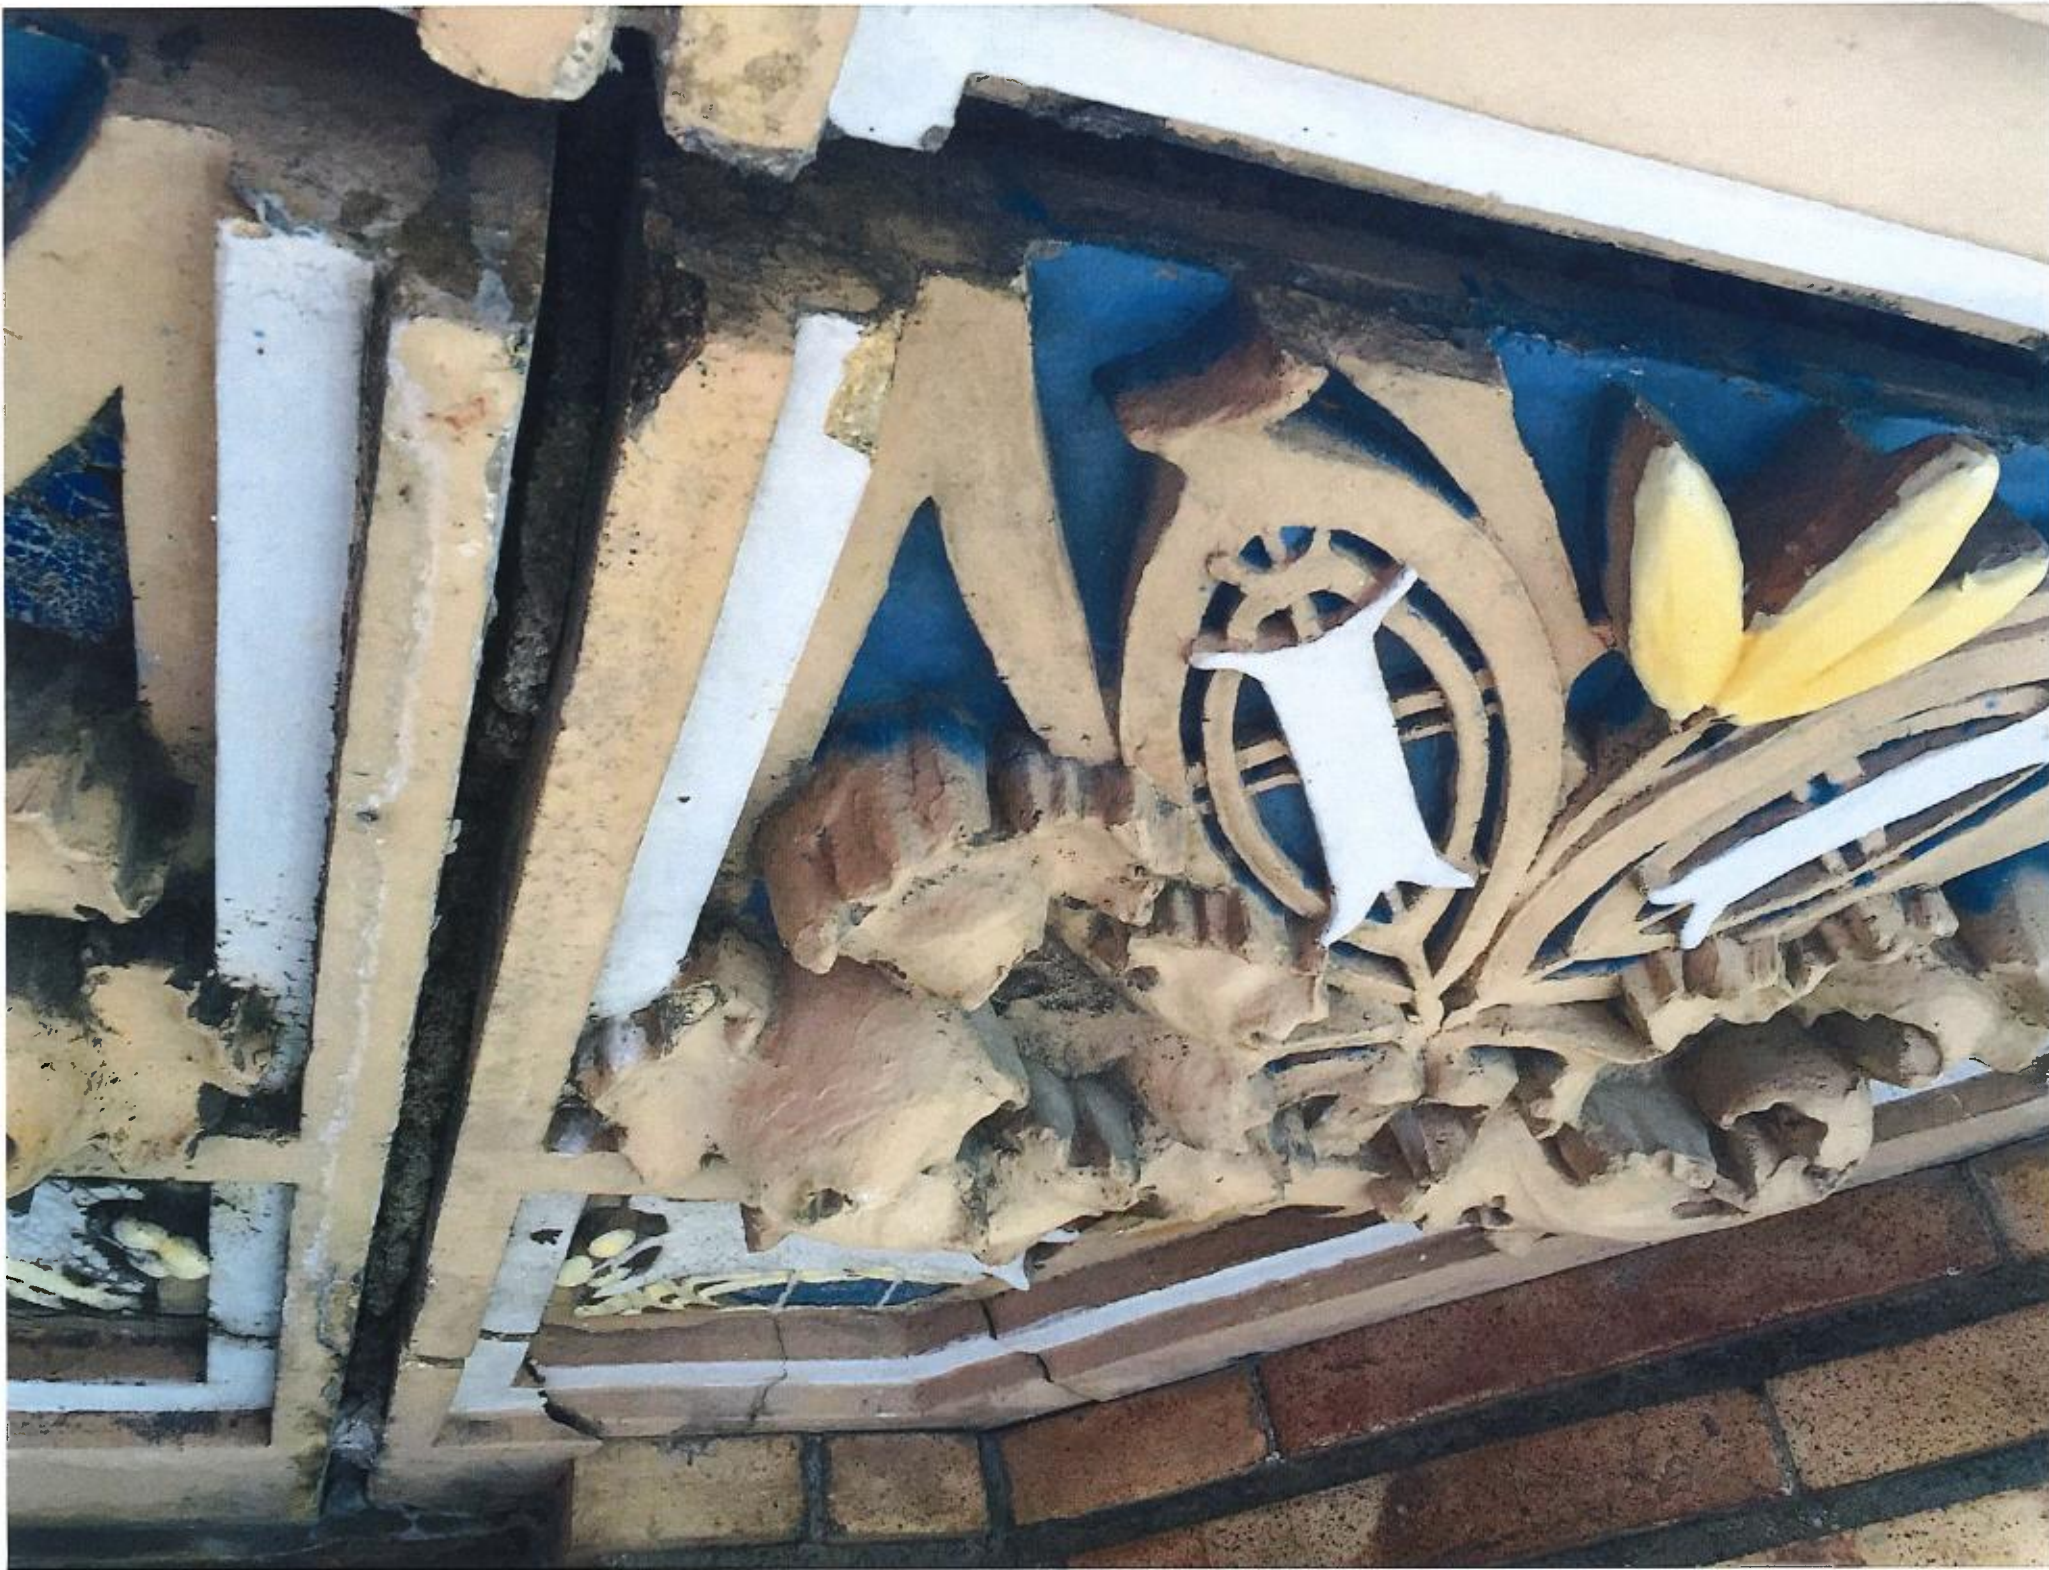
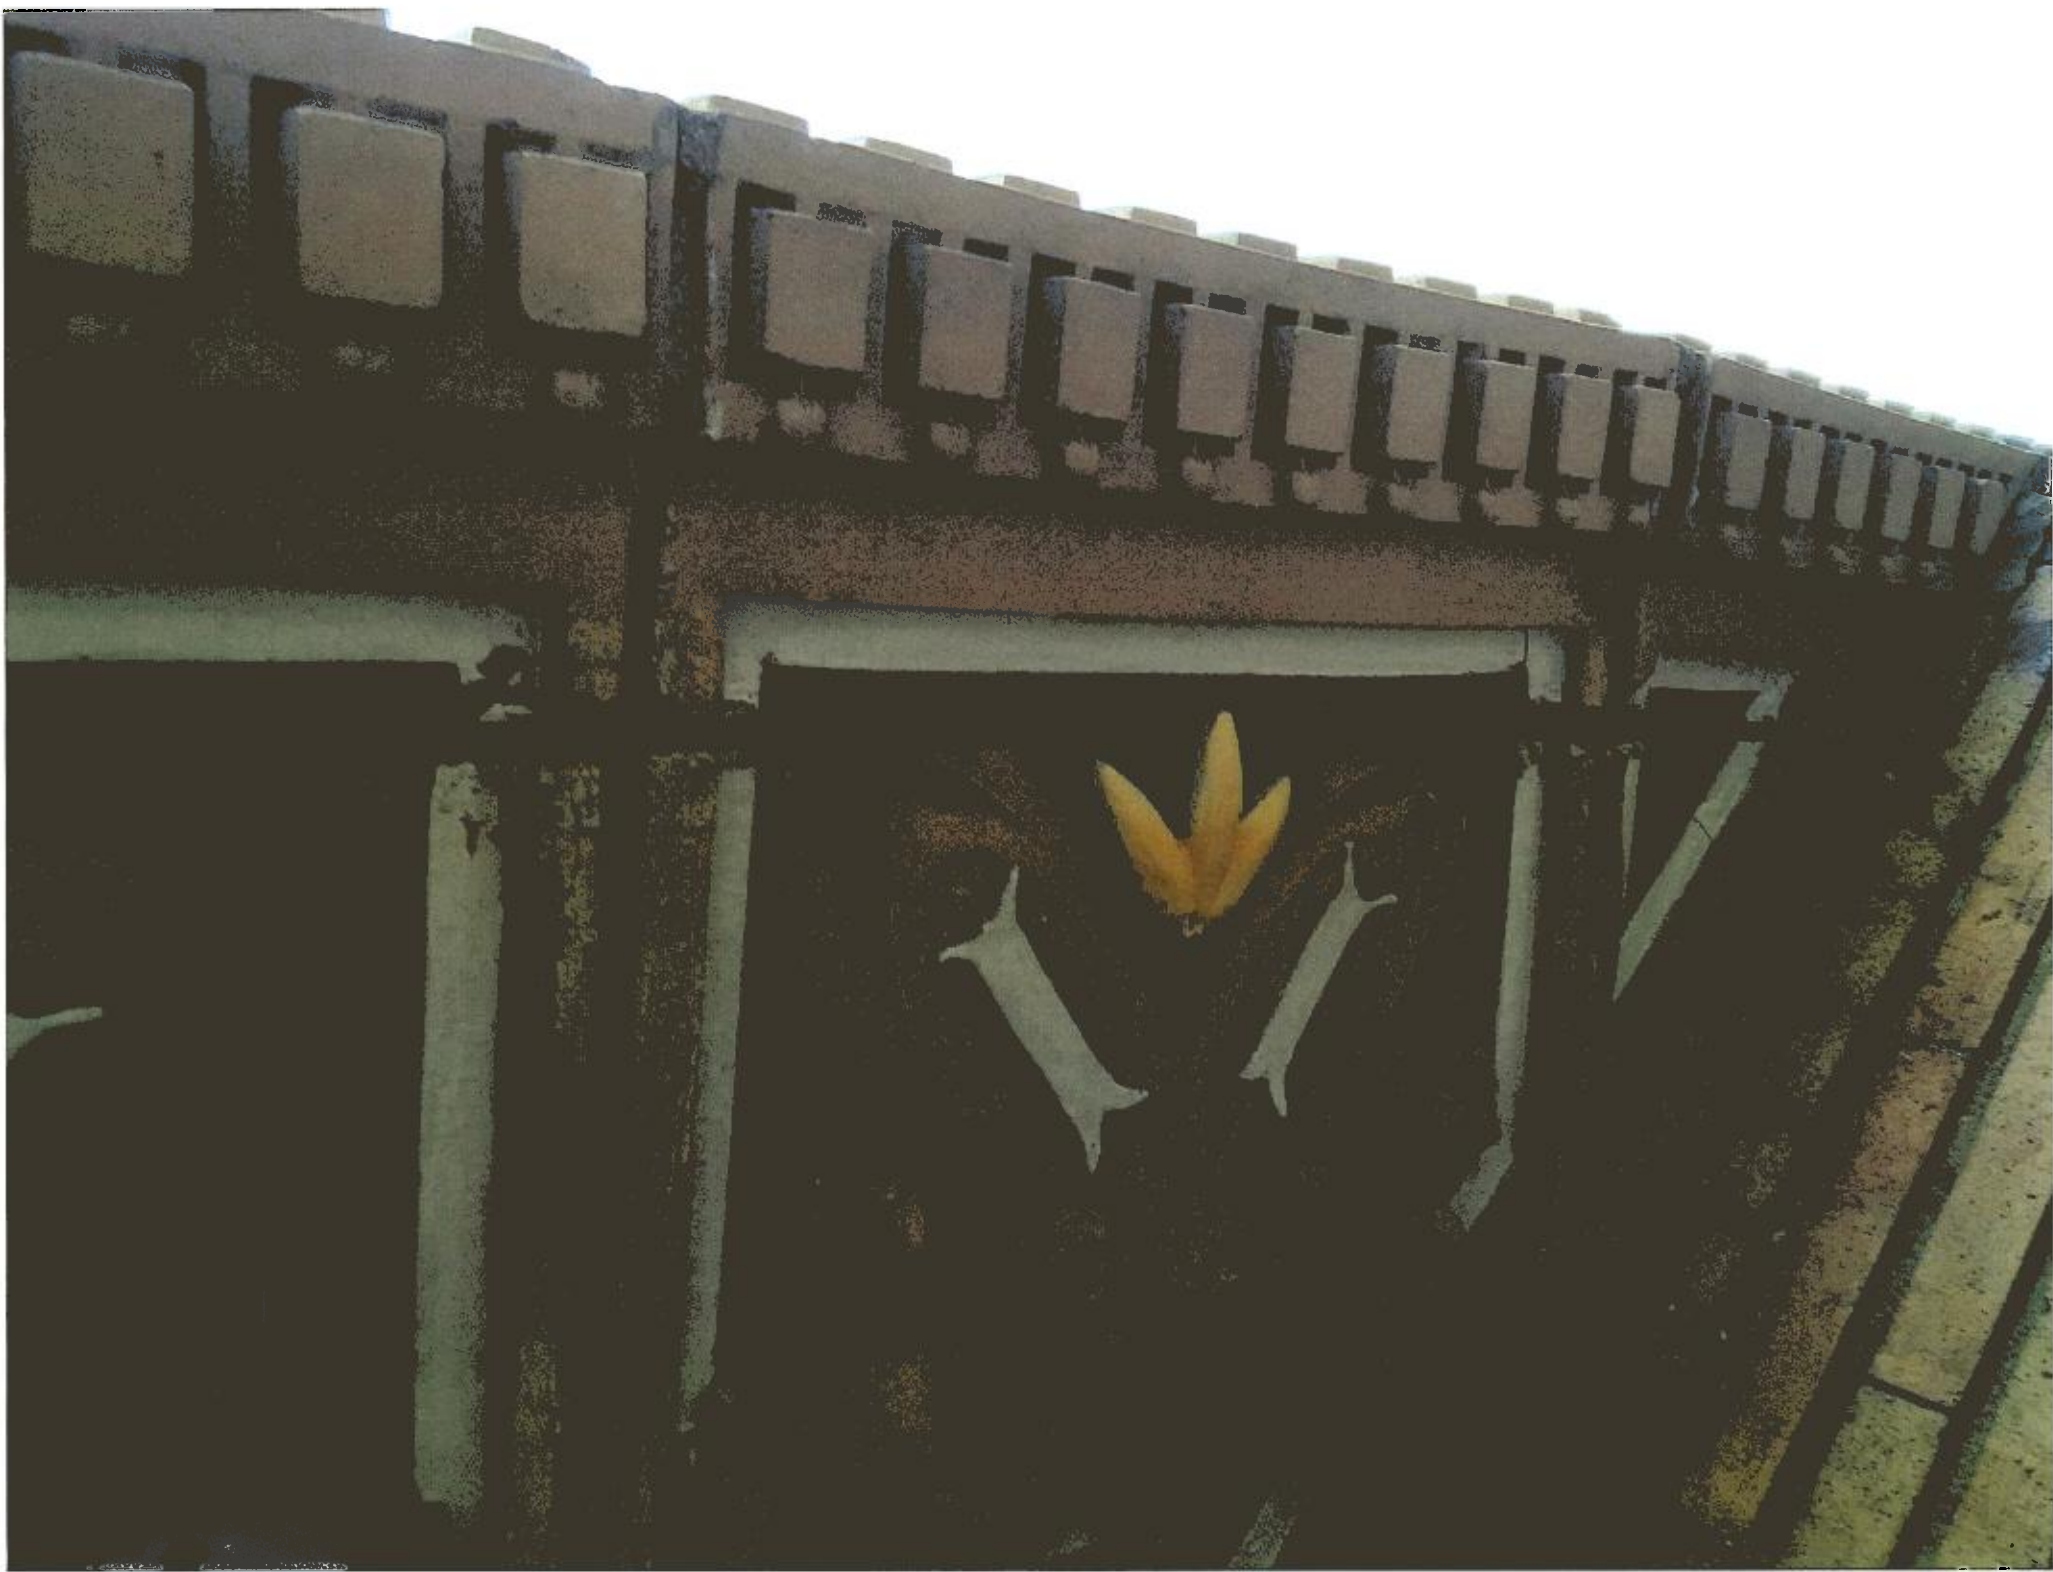
Conditions observed indicate severe deterioration as seen in photo images.

A great deal of mortar has fallen-out and is missing between the separate pieces of Terra Cotta including the top cap pieces. This allows rain water to penetrate the gaps. Rain water when frozen expands further speeding up the deterioration process by widening these areas and then allowing the water to make contact with the metal wires attached to structural beams that hold the Terra Cotta in place. It is not possible to determine the condition of the retaining wires without removing each Terra Cotta piece. There are several pieces of Terra Cotta that are sagging on all four sides of the building causing concern.

Building Services has placed this item on the Historical Committee meeting agenda scheduled for 9/01/2016 for discussion.
